4 カ月ごとの水温変化_2020.8~ (Stn.1)

4 カ月ごとの塩分変化_2020.8～ (Stn.1)

4 カ月ごとの溶存酸素 (DO) 変化_2020.8~ (Stn.1)

4 カ月ごとのクロロフィル濃度変化_2020.8～ (Stn.1)

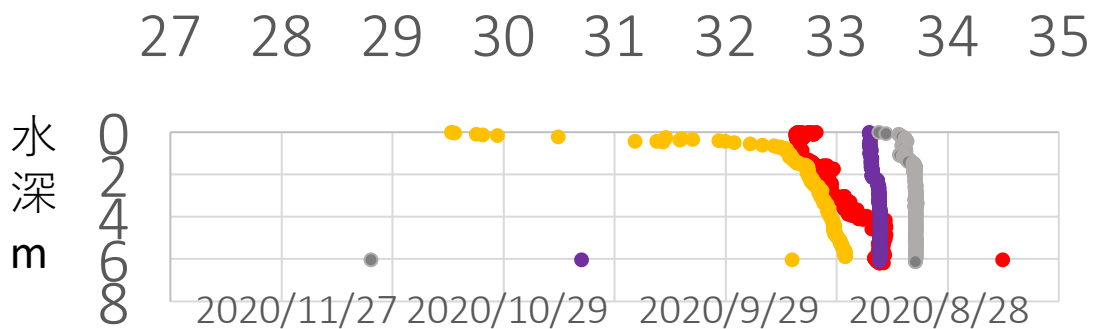
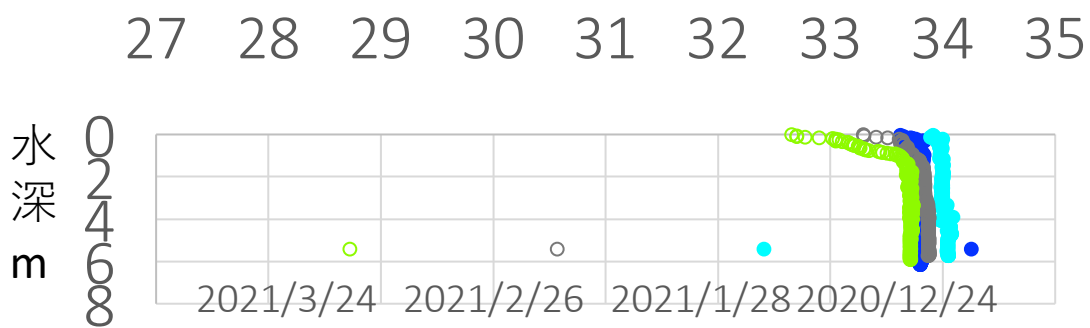
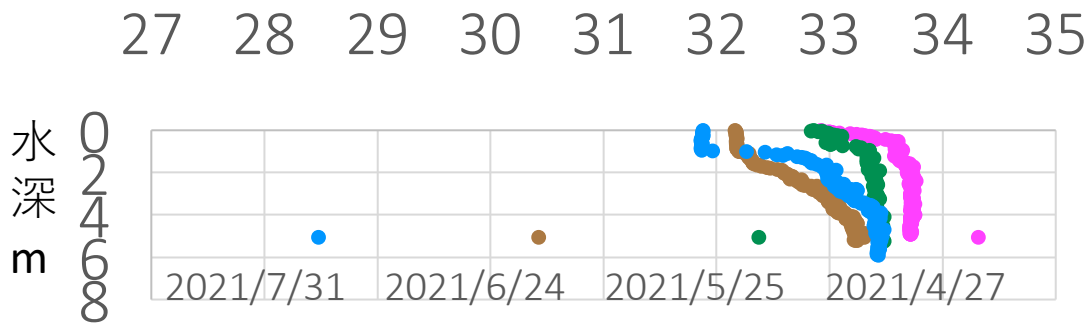
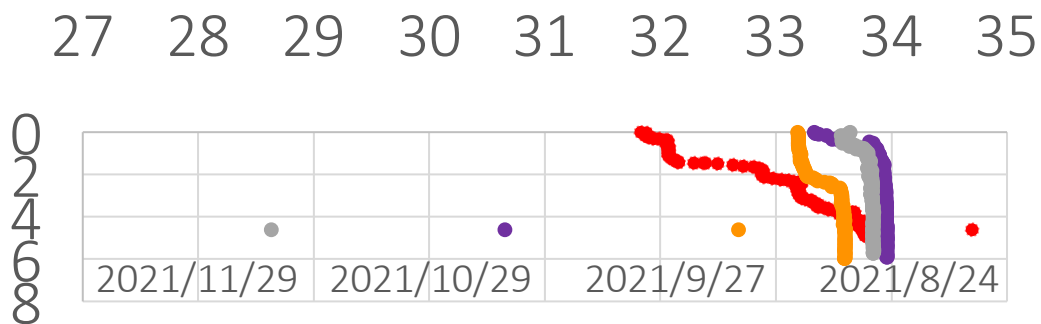
水尻川・八幡川の河口に近く、表層の塩分の値が低い。

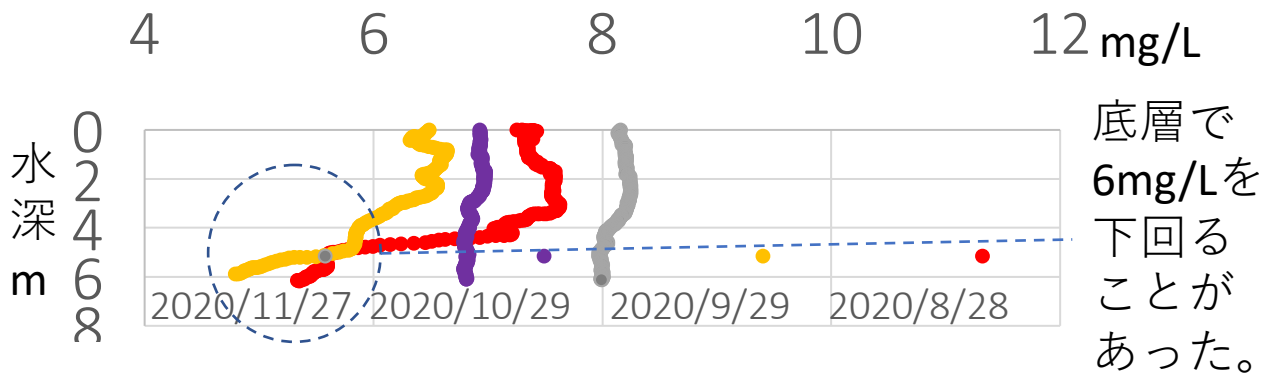
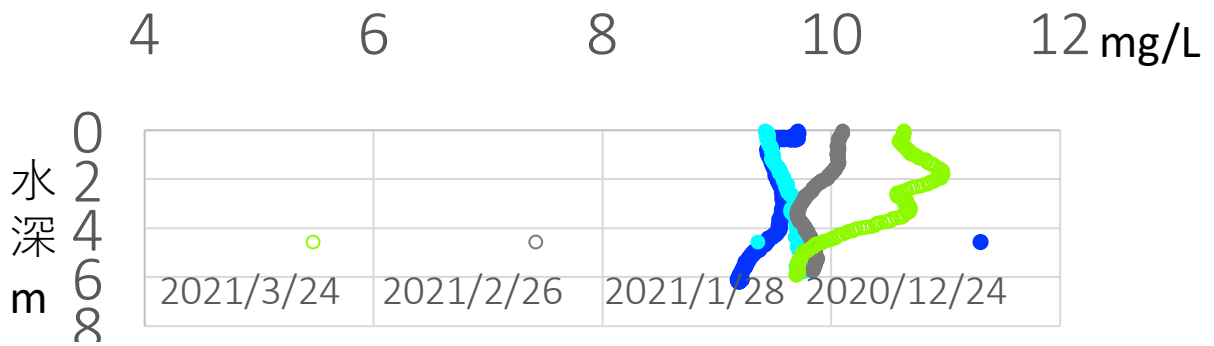
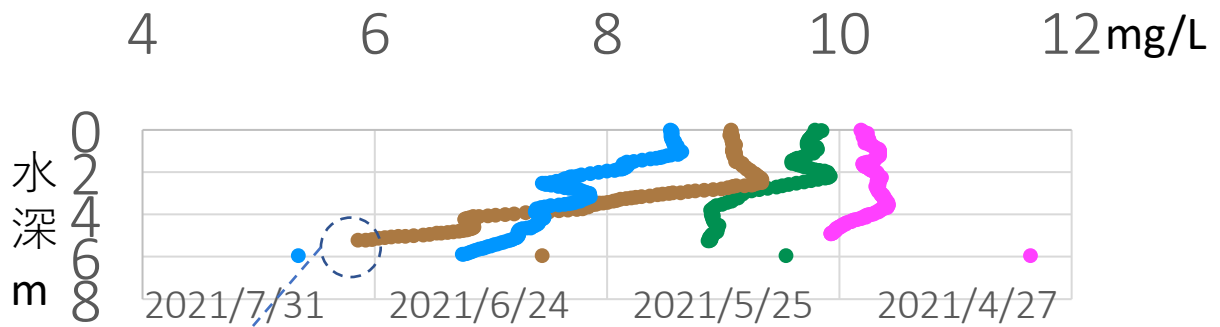
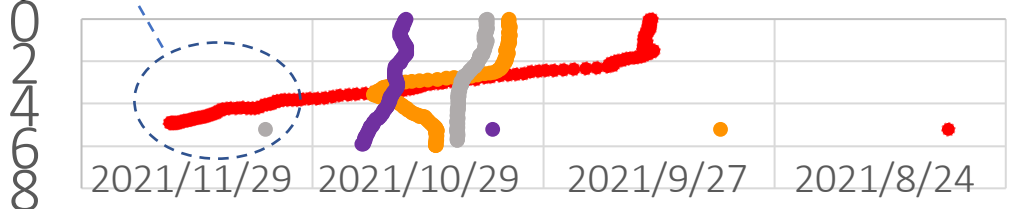
底層で
6mg/Lを
下回る
ことが
あった。
