4 カ月ごとの水温変化\_2020.8～ (Stn.3)

# 4 カ月ごとの塩分変化\_2020.8～ (Stn.3)

# 4 カ月ごとの溶存酸素（DO）変化\_2020.8～（Stn.3）

# 4 カ月ごとのクロロフィル濃度変化\_2020.8～ (Stn.3)

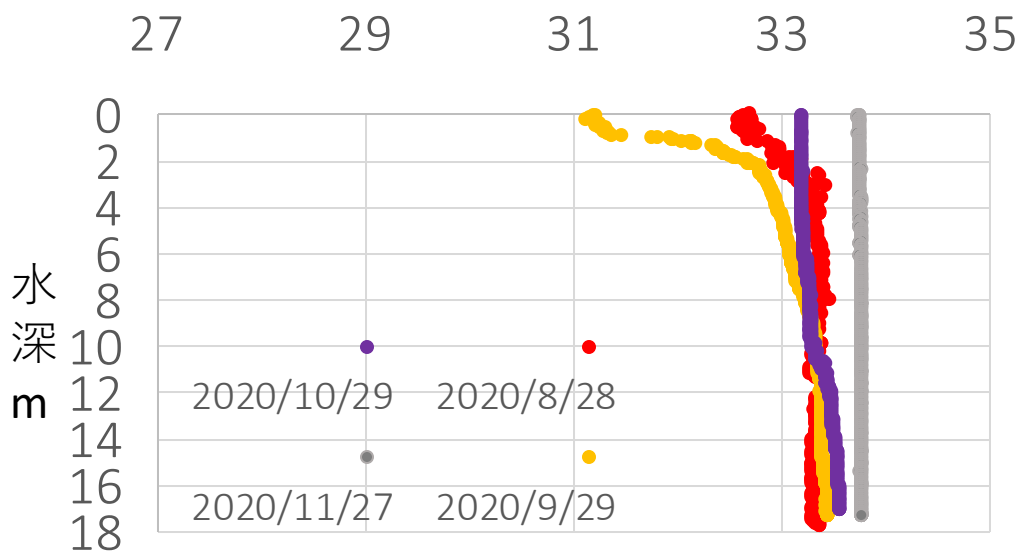
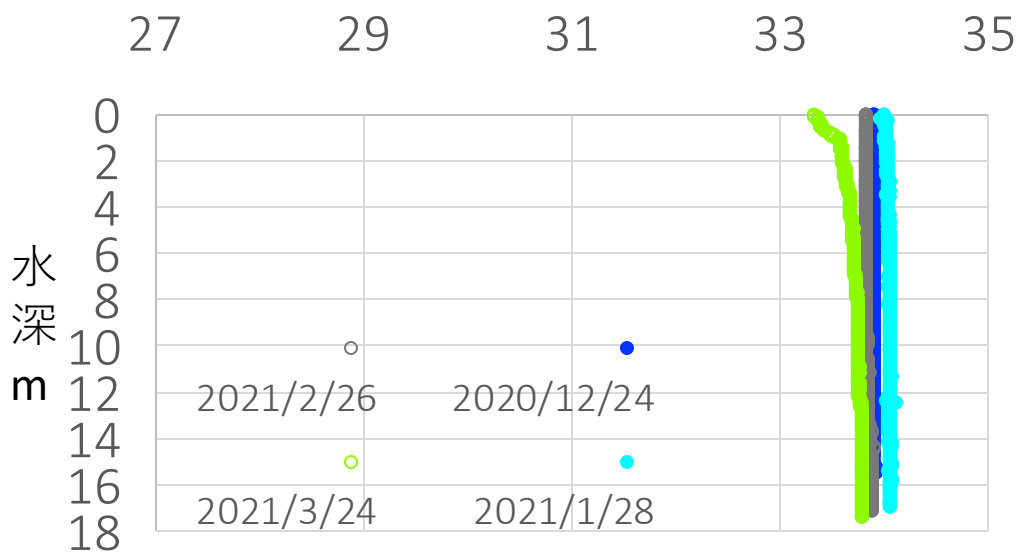
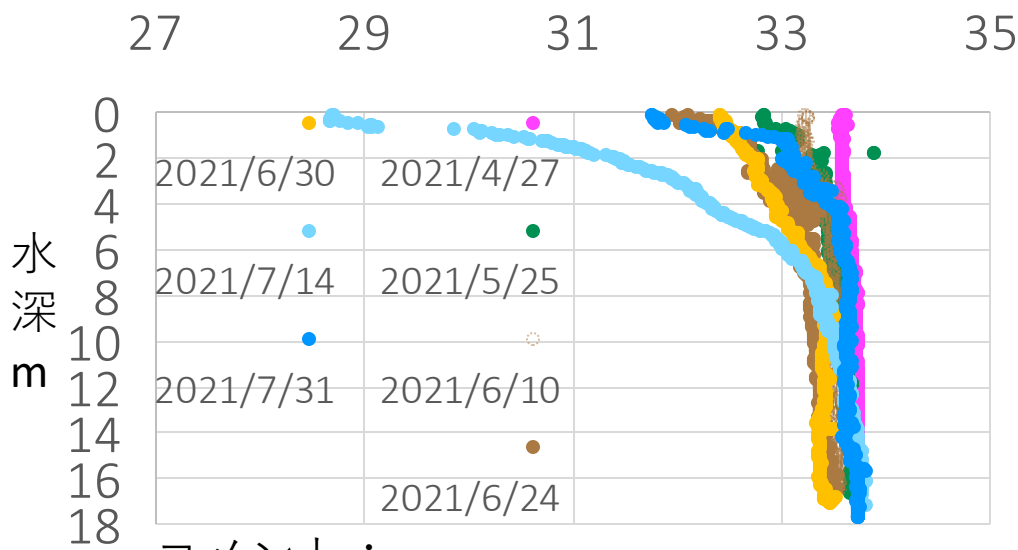
降雨後の表層水は塩分低下が見られる。
